Manhole Inspection Summary

Manhole # S55E__047MH

Insp Date: **6/11/08 10:46 AM**

Location Address: **3800 e pratt st**

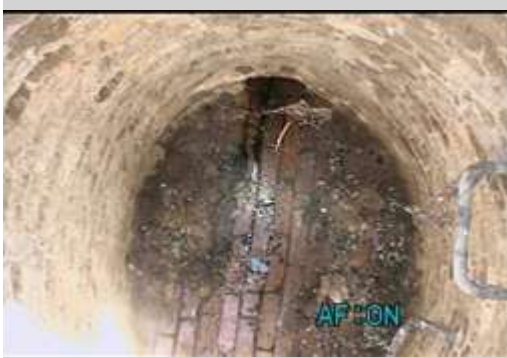
misc channel debris

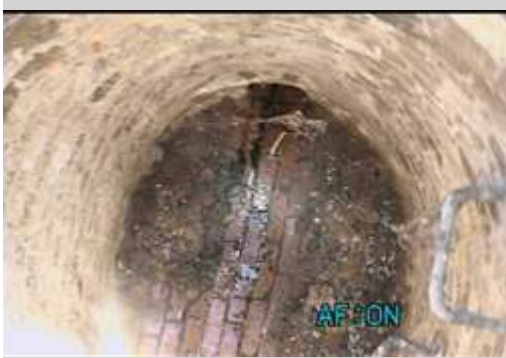
Defect 2

Count: **2** Missing: **0** ☒ **Corroded**

channel debris

steps

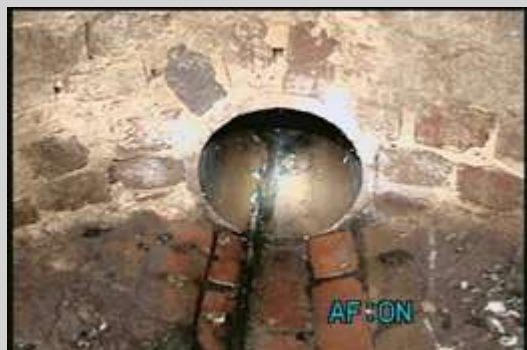
12 O'Clock Outflow

8 in. Circular Gravity Sewer
Pipe Out @ 12 O'Clock

Pipe Material: **Clay** ☐ Pipe Lined

Infiltration: **None** Pipe Seal Cond: **Unknown**
